TP 13479E

Contaminated Aircraft Takeoff Tests for the 1998-99 Winter

APS AVIATION INC.

October 1999

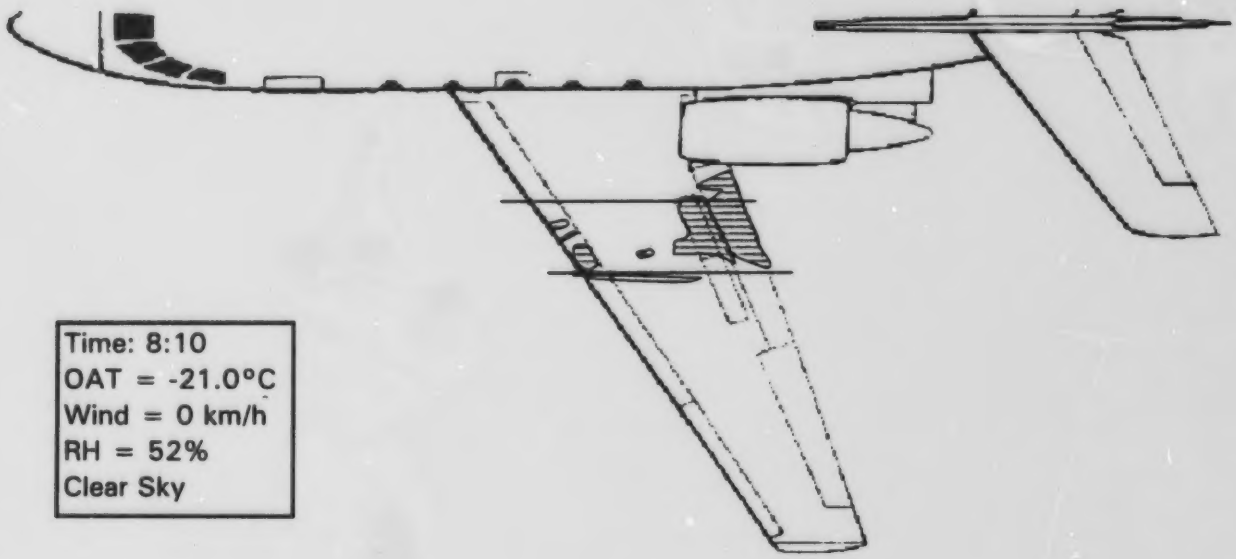
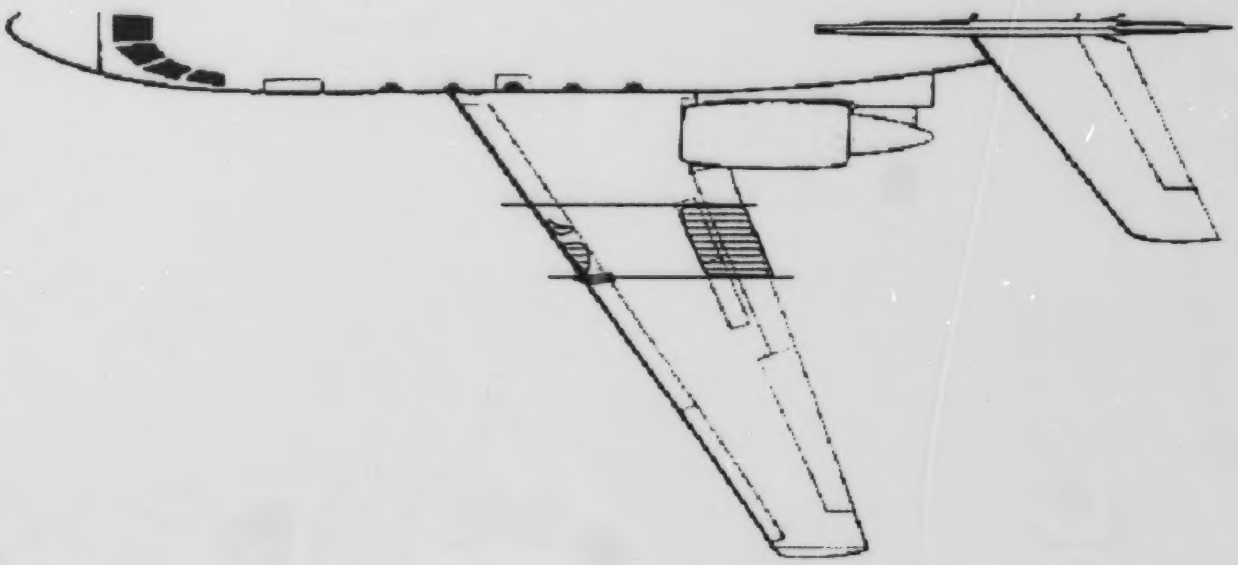
Ground Observer
On return from the takeoff run, the ice-covered area at the rear of the wing showed little reduction in size (Figure 4.18 and Photo 4.12). The ice patches on the leading edge appeared to have grown in a lateral direction.

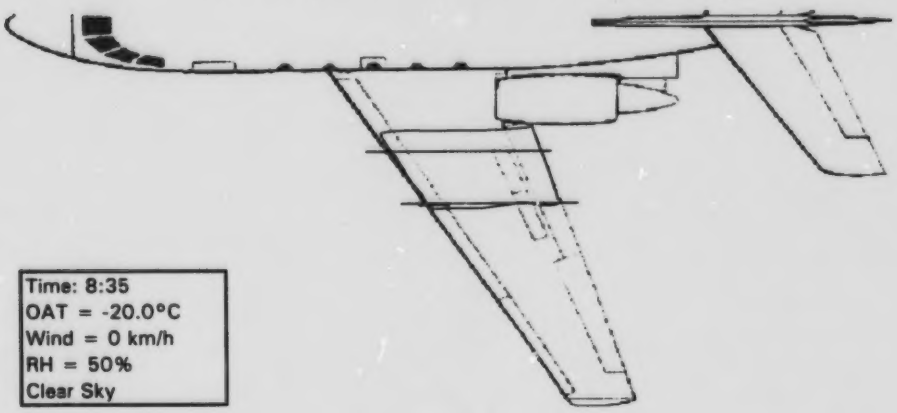
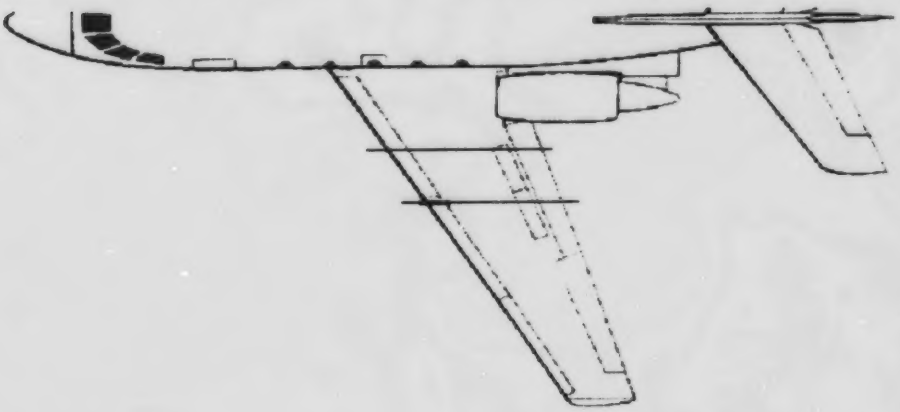
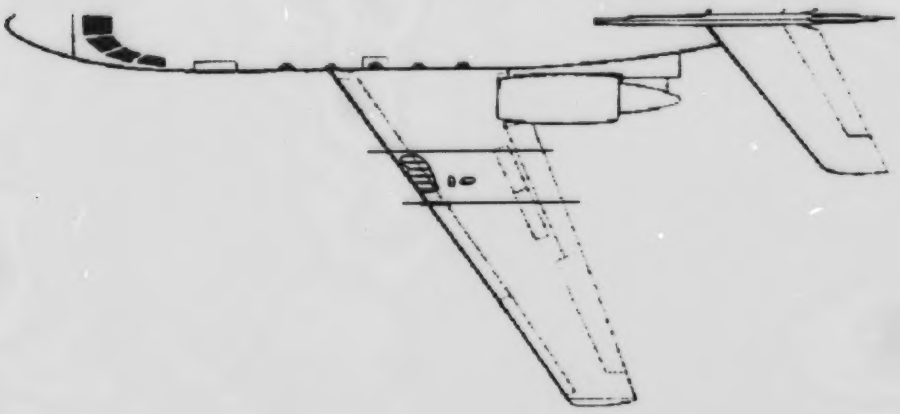
FIGURE 4.20

Experienced Cabin Observer
The experienced cabin observer noted that the fluid appeared to be slushy but that no ice was distinguishable. No failure pattern was recorded.

Pilot
The pilot indicated that ice had formed on the leading edge with patches farther back on the main wing. The pilot noted that the appearance of the fluid was not similar to previous runs.

Run 7 - Failure Pattern Before Takeoff Run

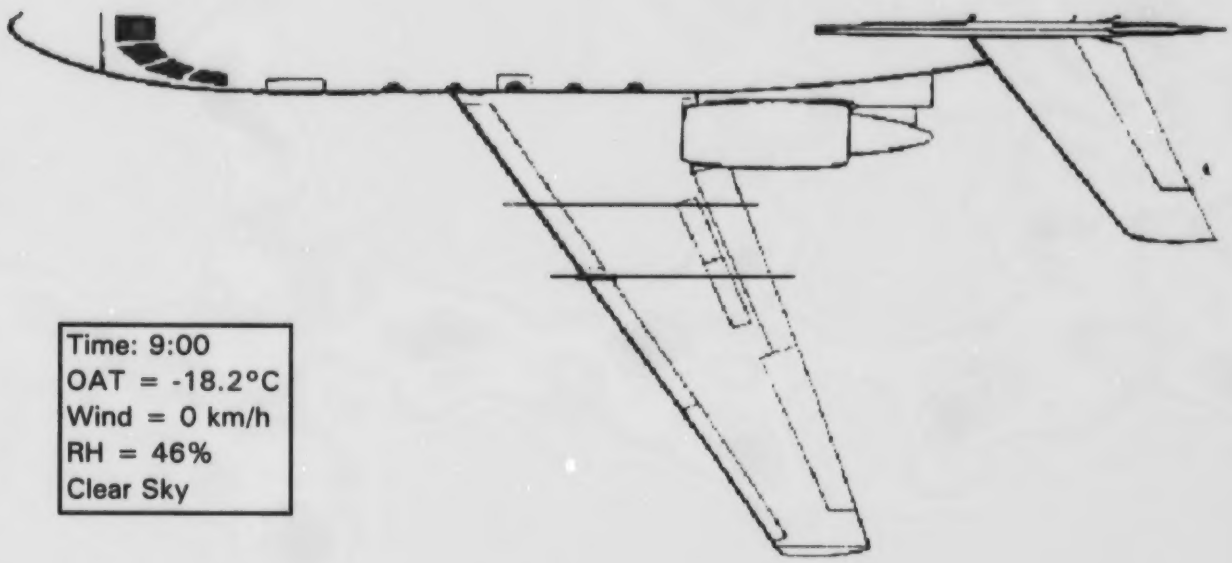
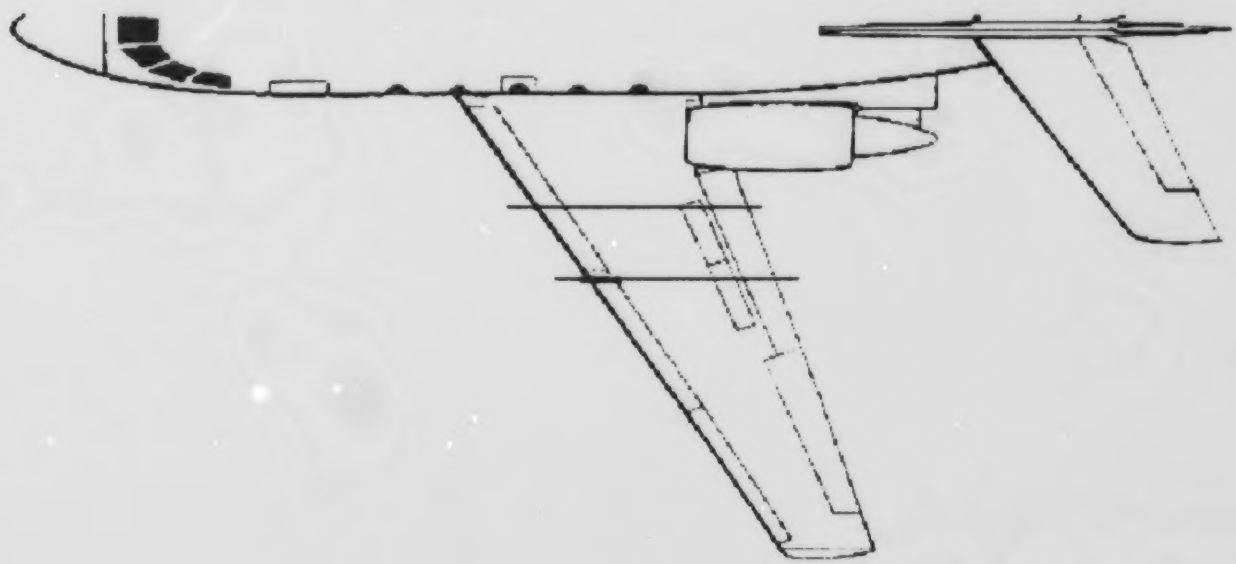
Run 7 - Failure Pattern After Takeoff Run

Ground Observer
On return from the takeoff run, it was observed that the entire fluid layer had been eliminated from the wing (Figure 4.22). The results are similar to those of Run 4, which also employed the propylene glycol-based fluid, but with no contamination. No solids remained, and any fluid that remained on the wing took on the appearance of lateral ridges running perpendicular to the wing chord. Photo 4.14 shows the clean wing following the takeoff run.

Experienced Cabin Observer
The observer noted that the wing was clean and that the slush had been sheared off completely and rather spectacularly during the takeoff run.

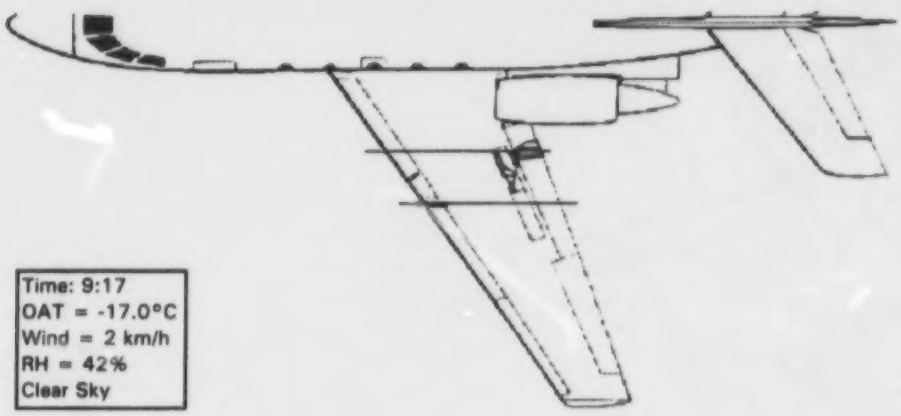
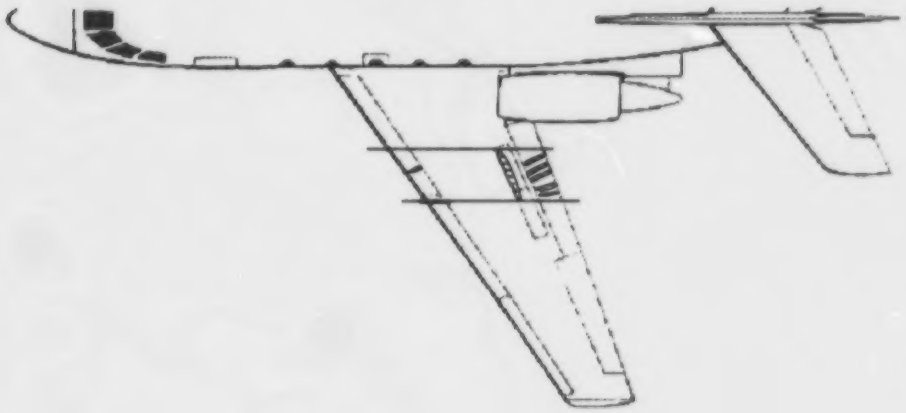
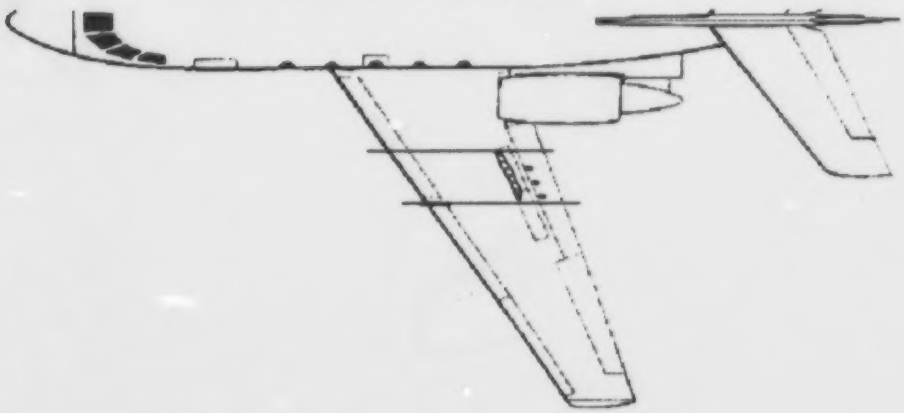
FIGURE 4.24

A small ice patch (Figure 4.23 and Photo 4.15) appeared on the leading edge and slightly larger patches were observed on the spoiler panel and on the flap. The wing observer noted that flow off from the top of the main wing eroded the fluid in these areas, leading to failures. The iced area on the leading edge was located at a seam in the leading edge structure. This area had also been the site of initial failures in previous tests.

Experienced Cabin Observer
The experienced cabin observer noted the patch of ice on the leading edge and on the spoiler panel.

Pilot
The pilot noted the existence of an ice patch on the spoiler panel and some on the flap, but did not identify the small area on the leading edge.

Run 8 - Failure Pattern Before Takeoff Run

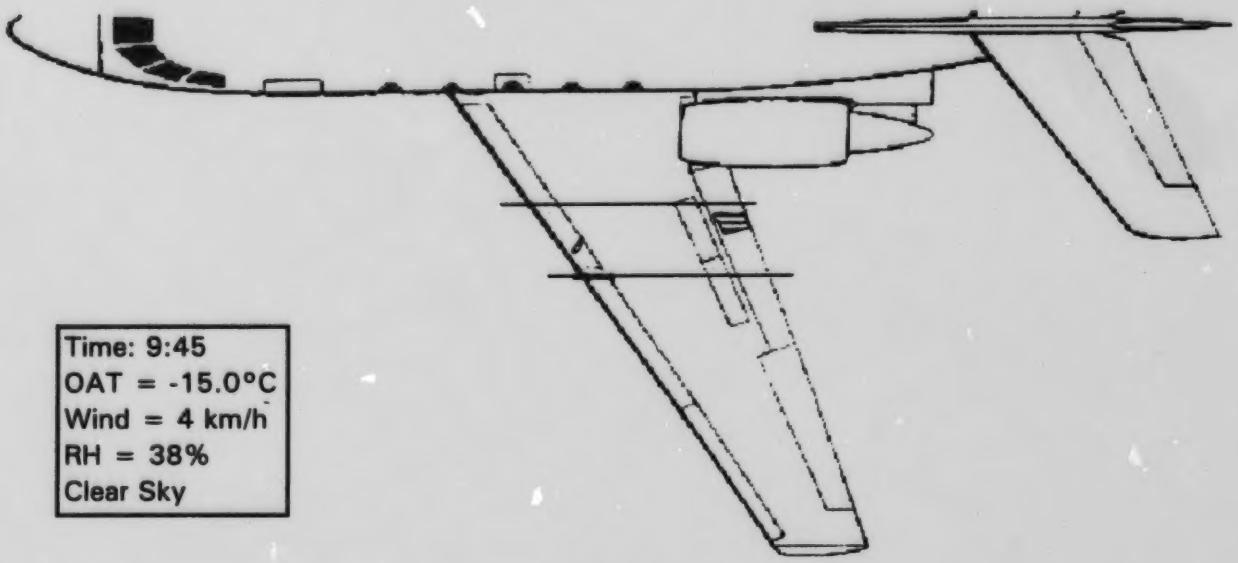
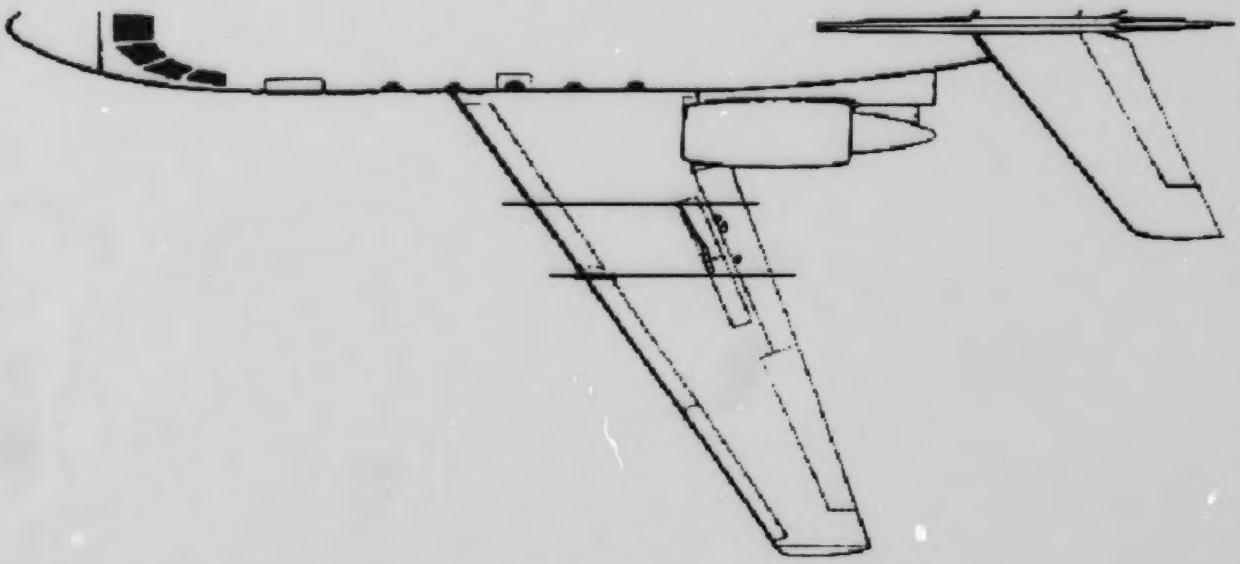
FIGURE 4.26

Ground Observer
On return from the takeoff run, the ice on the spoiler panel had disappeared, but the ice patch on the flap remained (Figure 4.26 and Photo 4.16). The ice patch at the seam in the leading edge was somewhat reduced in size but was still visible.

Run 8 - Failure Pattern After Takeoff Run

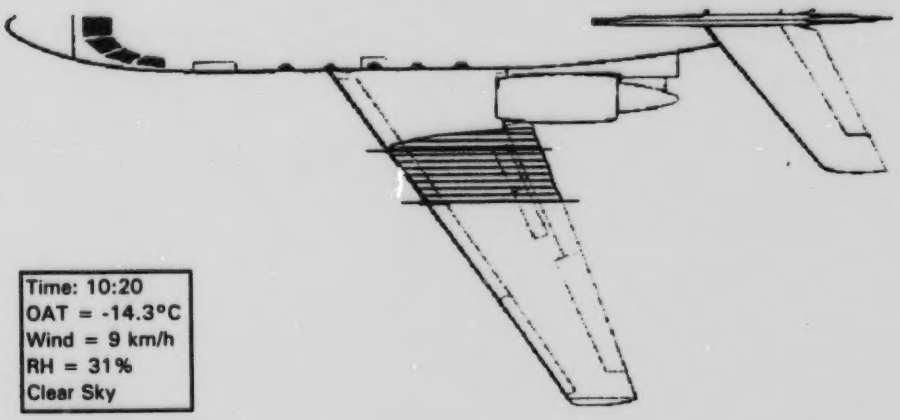
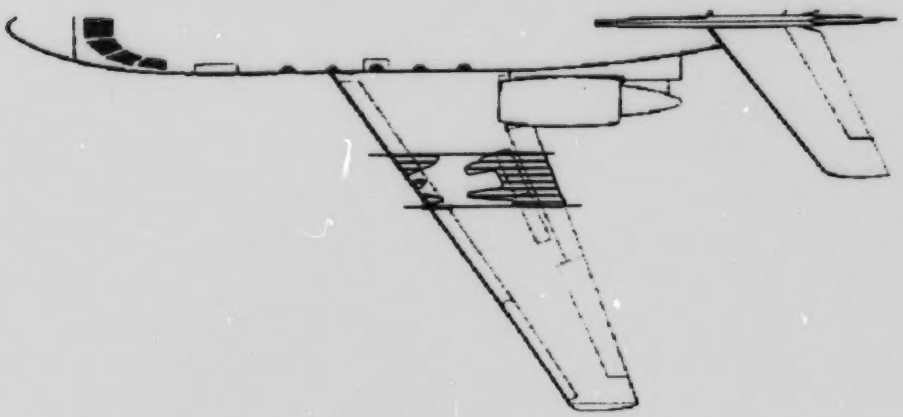
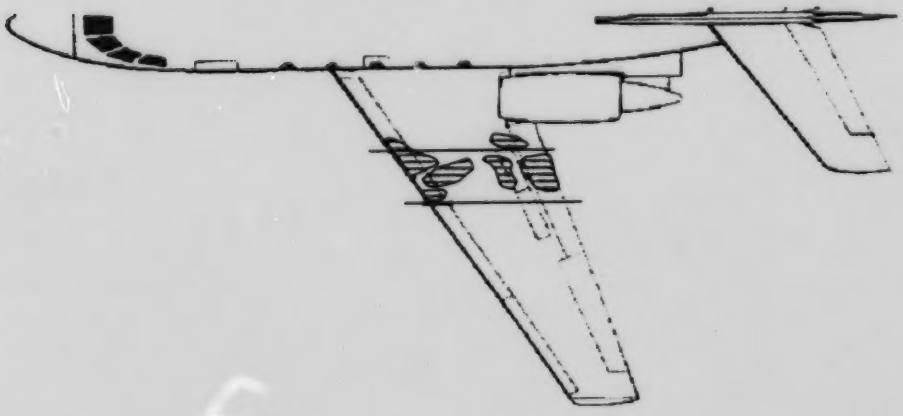
Pilot
The pilot record indicates patches of ice distributed over the entire test area.

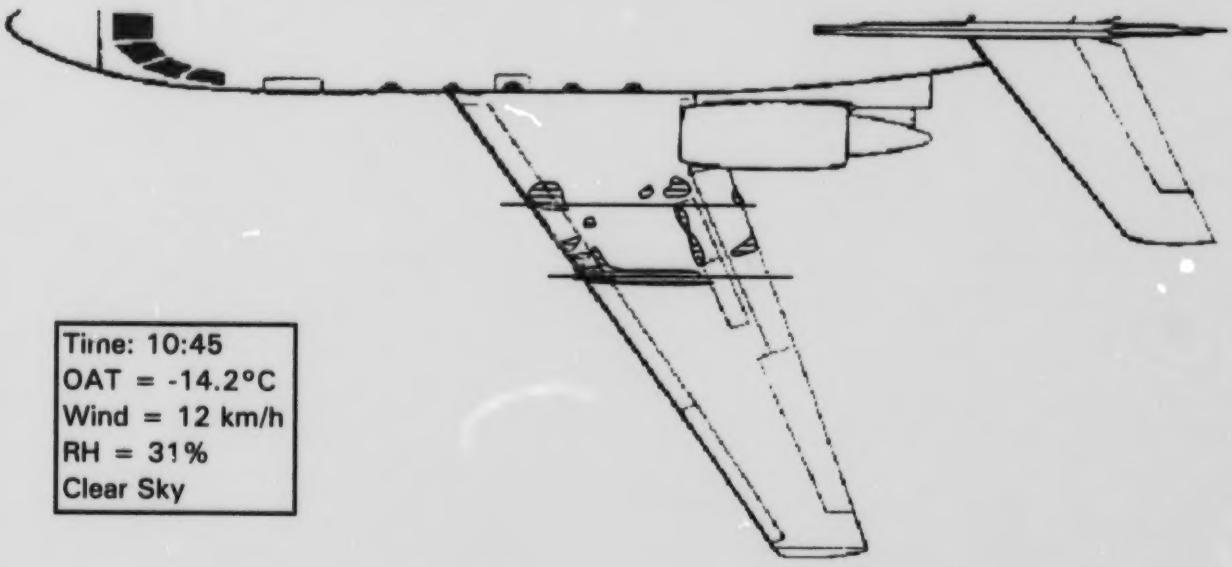
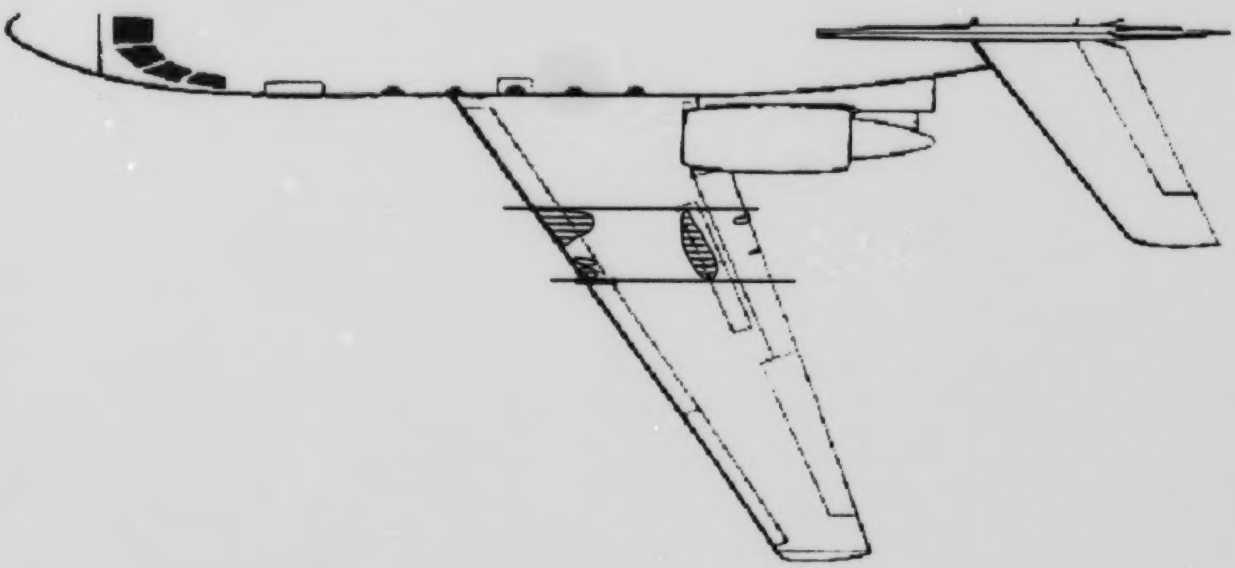
FIGURE 4.30

Experienced Cabin Observer
The cabin observer recorded the ice remaining on the wing surface as very similar to that recorded by the ground observer.

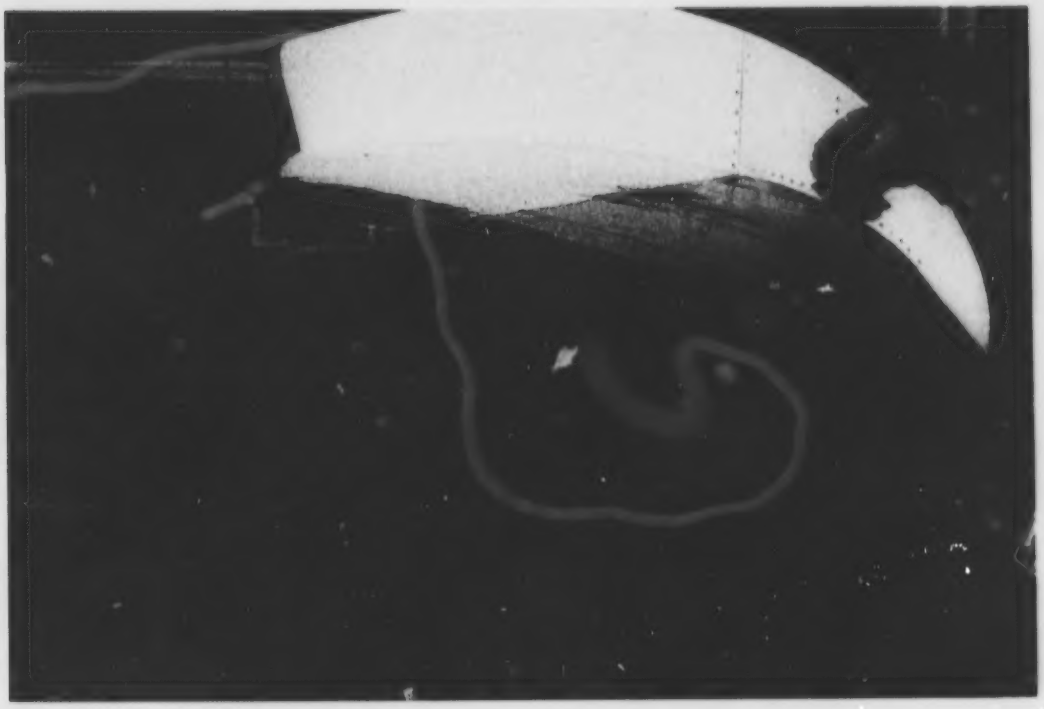
Photo 4.5
Run 3 - Appearance of Fluid Prior to Takeoff Run
Ethylene Glycol-Based Type IV Fluid at 10 Percent Contamination

Ice on Leading Edge

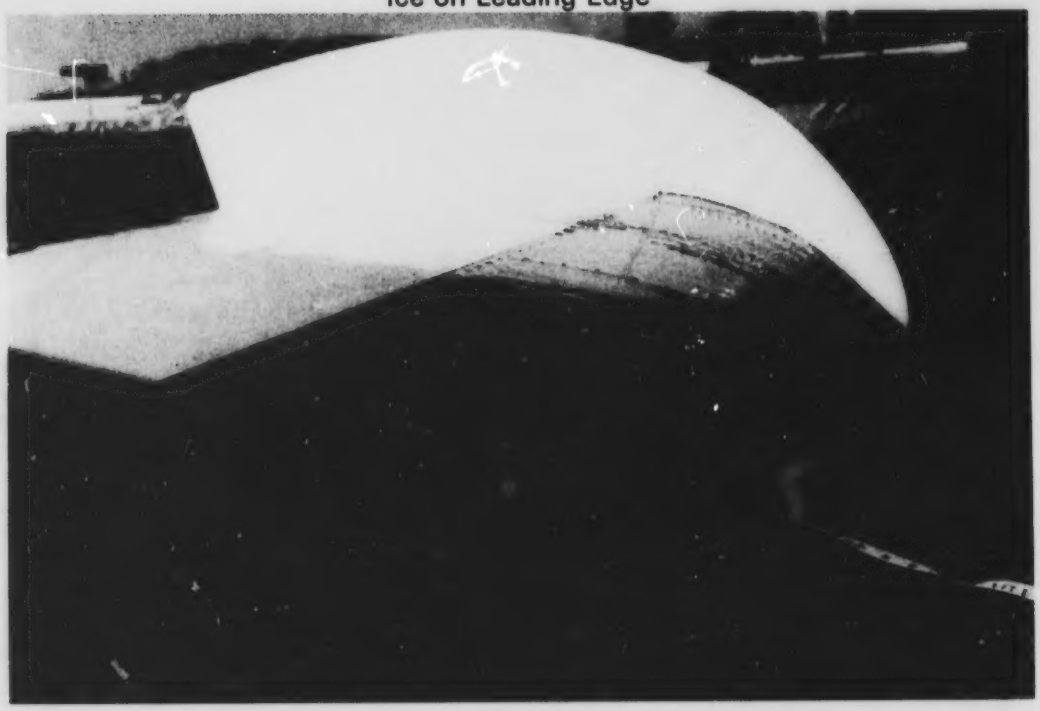
Photo Set 4.6
Run 3 - Appearance of Fluid Following Takeoff Run

Ground Observer
On return from the takeoff run, the ice-covered area had been reduced in area by about 50 percent (Figure 4.9). Photo Set 4.6 shows the ice formations remaining on the leading edge. The iced area farther back on the wing appeared to have undergone a greater reduction than that at the leading edge. This indicated either that a greater degree of adhesion existed on the leading edge or that the fluid shedding action on the takeoff run partially cleared off the rear wing contamination as the fluid was swept off the wing.

Ice on Leading Edge

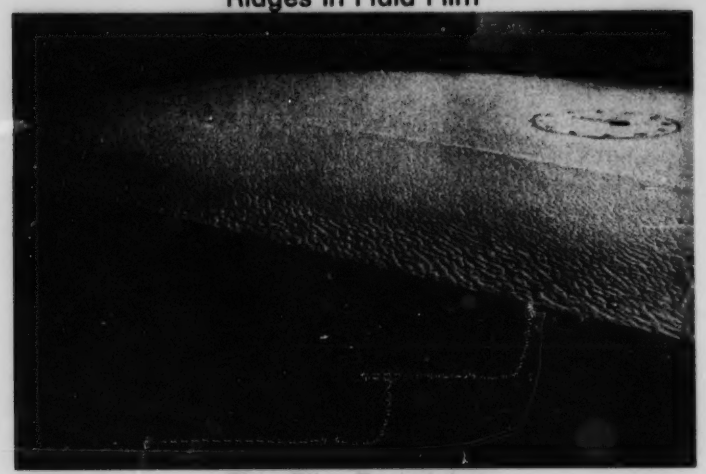
Photo Set 4.8
Run 4 - Appearance of Fluid Following Takeoff Run

Ridges in Fluid Film

Thin Film Remaining

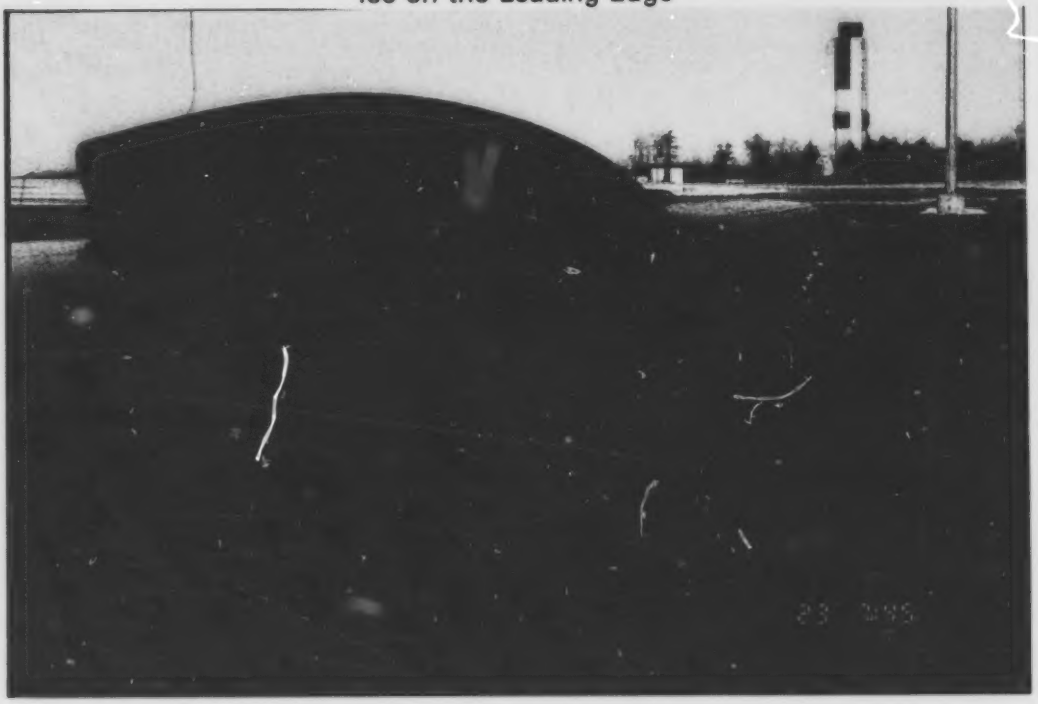
Photo 4.11
Run 6 - Appearance of Fluid Prior to Takeoff Run
Ethylene Glycol-Based Type IV Fluid at 5 Percent Contamination

Ground Observer
This trial was initially intended to result in an iced area of 1 percent of the test area. In an attempt to contain the extent of icing to that level, the freezing rain spray was terminated at the first sign of icing, which in this case occurred on the leading edge. See Figure 4.15 and Photo 4.11. As in the previous test, freezing of contamination continued after the spray had ceased, resulting in a final iced area of about 5 percent.

Ice on the Leading Edge

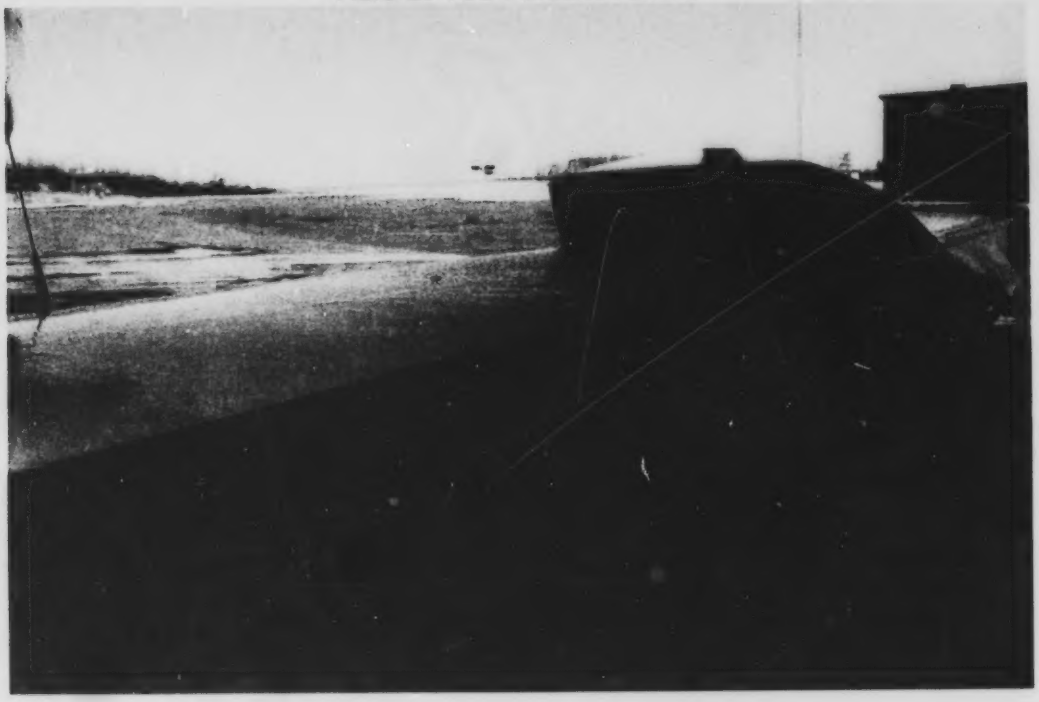
Photo 4.13
Run 7 - Appearance of Fluid Prior to Takeoff Run
Propylene Glycol-Based Type IV Fluid at 100 Percent Contamination

Fluid at 100 Percent Failure

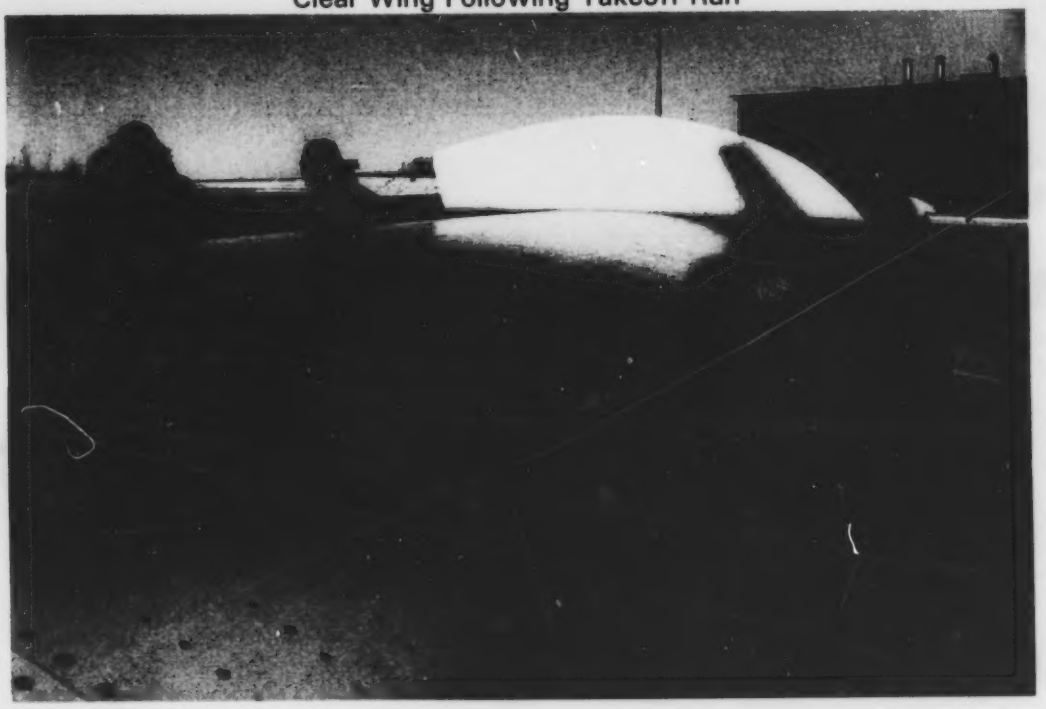
Photo 4.14
Run 7 - Appearance of Fluid Following Takeoff Run

Clear Wing Following Takeoff Run

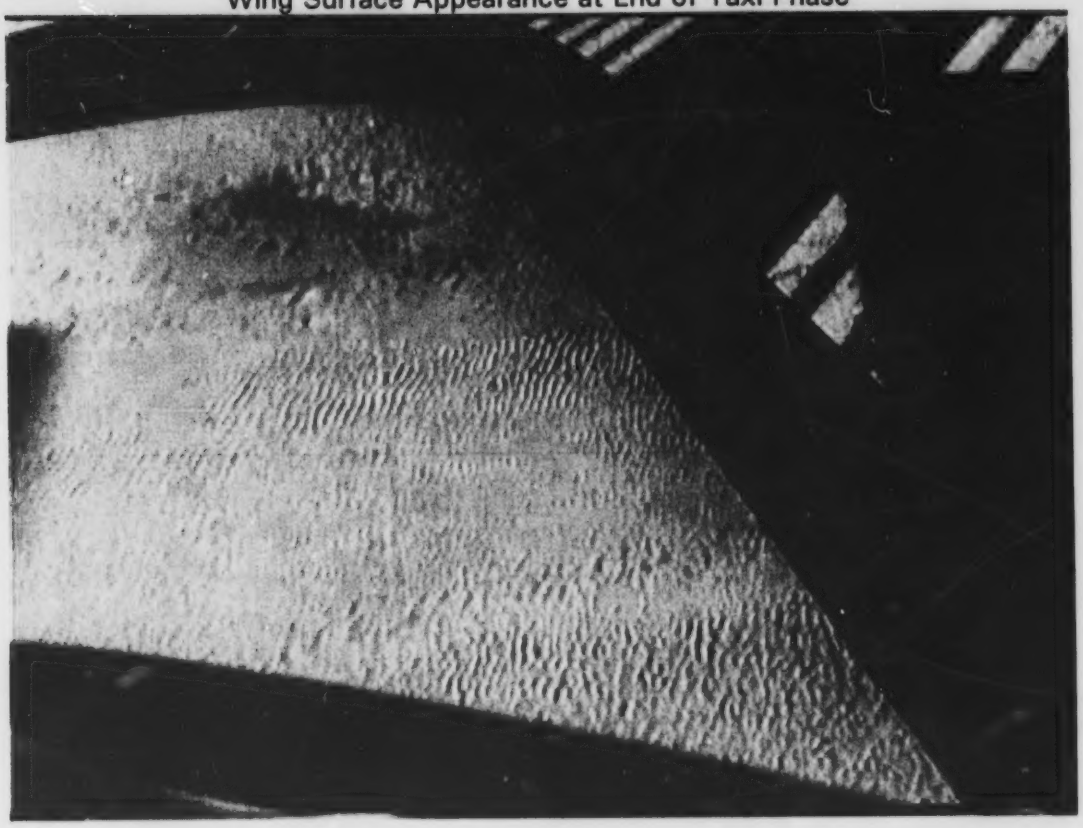
Video Image 4.3
Run 7 - Propylene Glycol-Based Fluid, at 100 Percent Failure

Video Image 4.3 provides a good view of the appearance of the layer of solid precipitation on the top surface of this fluid. As the aircraft turned off the taxiway and onto the runway, the wing passed through direct sunlight, which afforded this view. A good deal of this contaminant layer had already been eroded from the wing during the taxi phase; however, a conspicuous patch of contamination on the top of the mid-wing section still remained at the beginning of the takeoff run.

Wing Surface Appearance at End of Taxi Phase

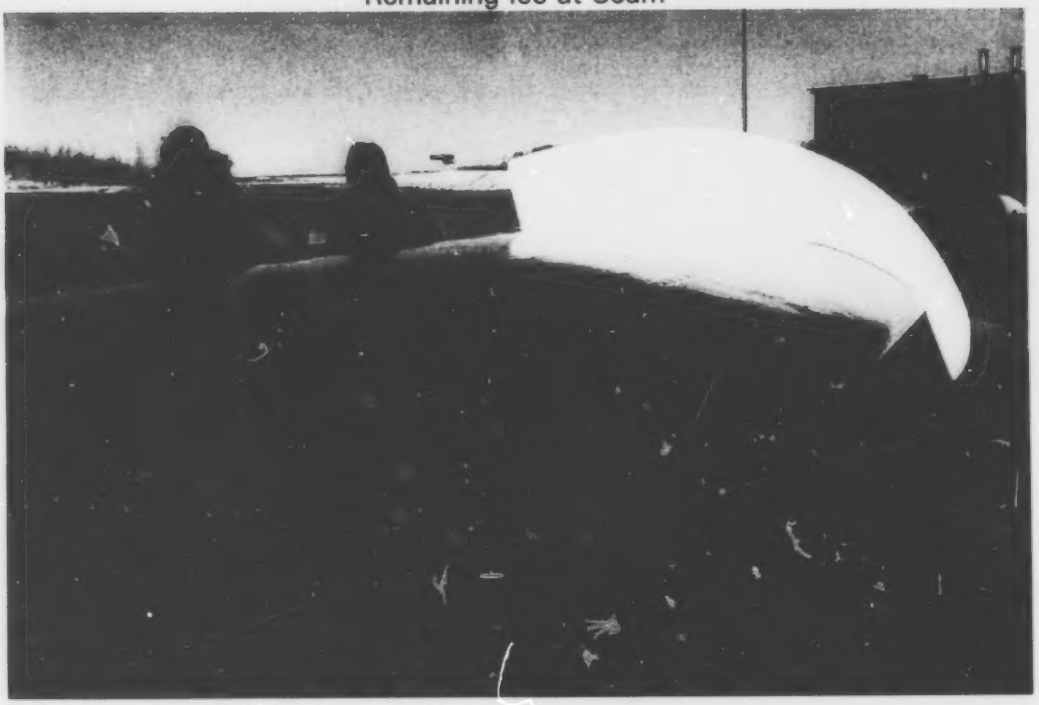
Photo 4.16
Run 8 - Appearance of Fluid Following Takeoff Run

Remaining Ice at Seam

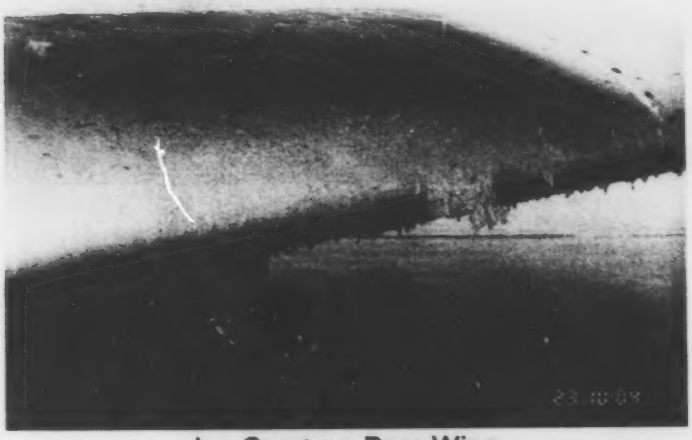
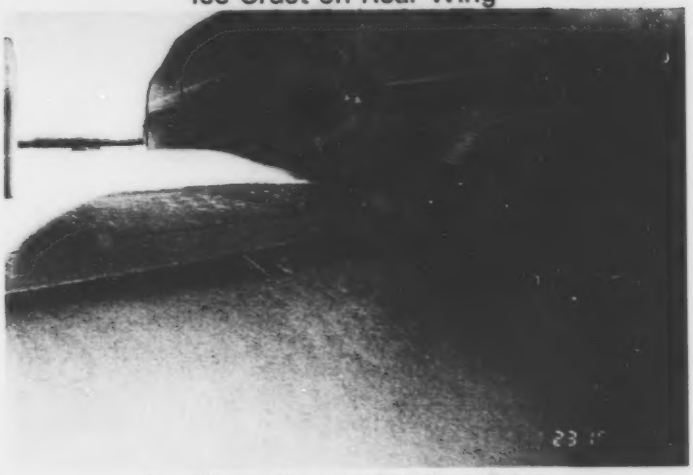
Photo Set 4.17

Run 9 - Appearance of Fluid Prior to Takeoff Run

Ice Crust Sliding Forward

Ice Crust on Rear Wing

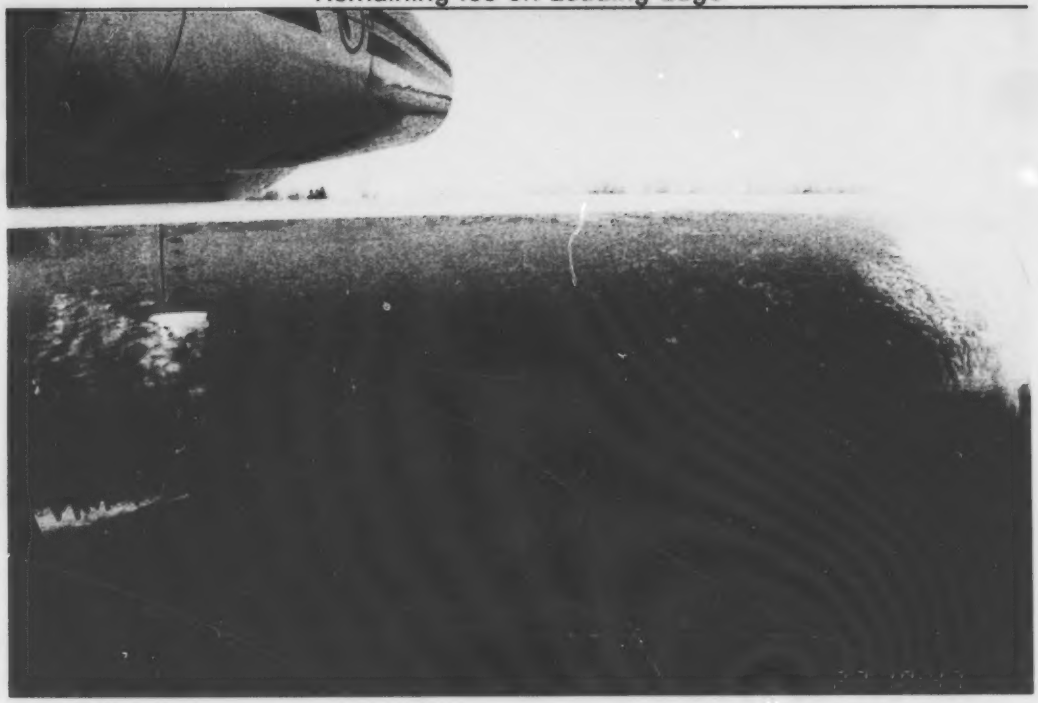
Photo 4.18
Run 9 - Appearance of Fluid Following Takeoff Run

Ground Observer
On return from the takeoff run, it was observed that those areas where, prior to takeoff, a light layer of ice had formed on the fluid surface were now clean of ice *and* of fluid. Areas where ice of substantial thickness had formed prior to the takeoff run remained ice-covered after the aircraft returned to the inspection pad. See Figure 4.30 and Photo 4.18.

Remaining Ice on Leading Edge

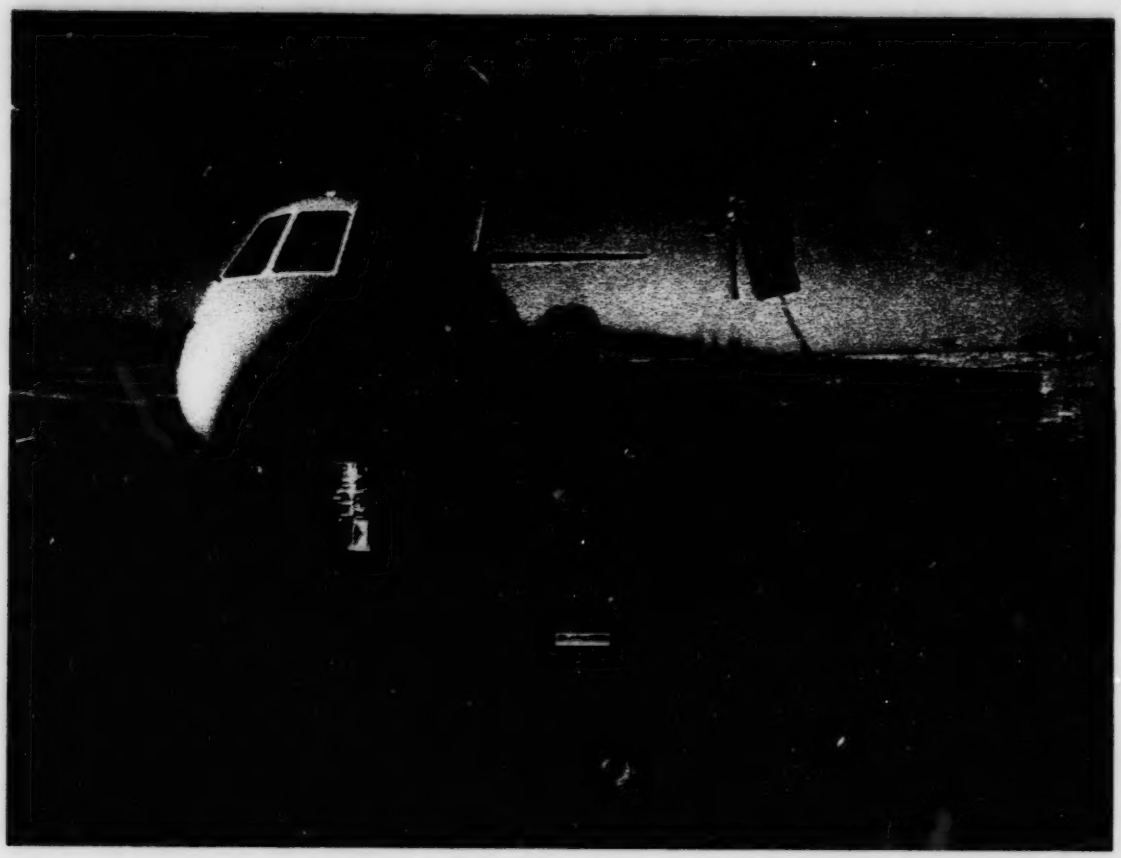
When the desired level of contamination was reached the ground crew recorded the condition of the fluid and contamination, as well as a visual description/estimate of the contamination from inside the aircraft. Figure 5 shows the ground crew applying contamination and making observations.
